Pictures 1 – 8 (Miscellaneous Tasks Performed Throughout the Three Bearing Changes)

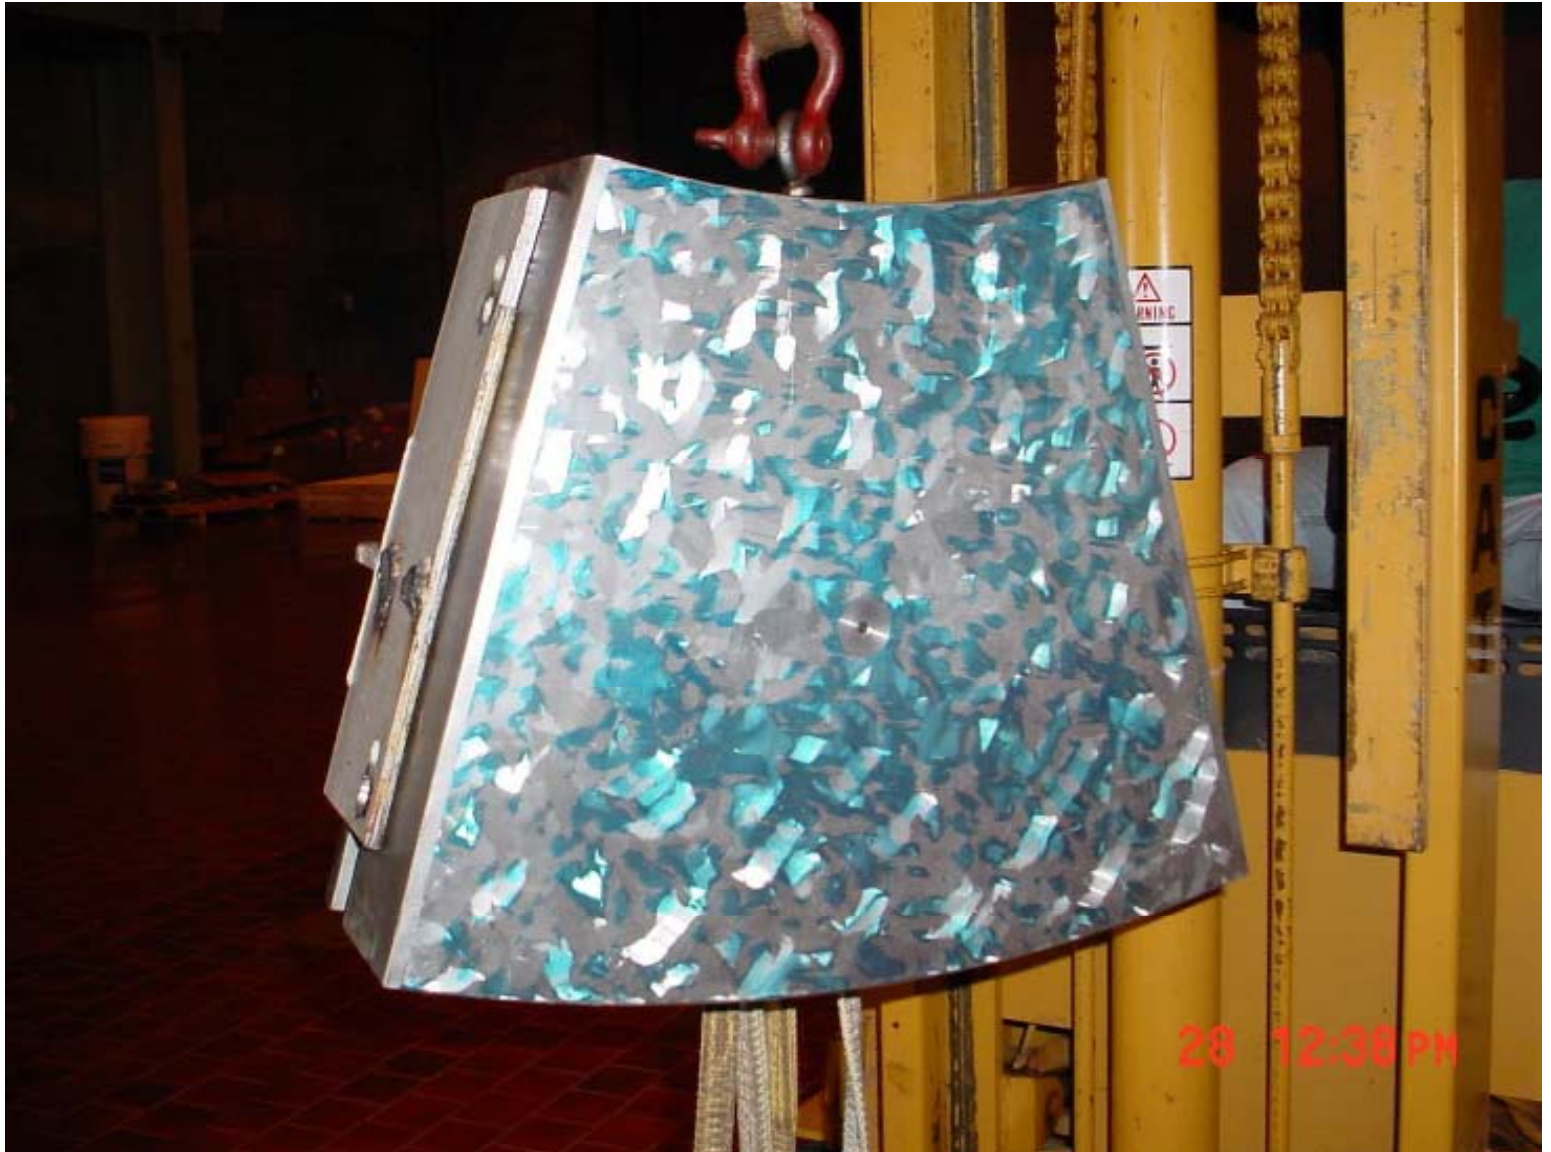
Picture 1 (Bearing Check):

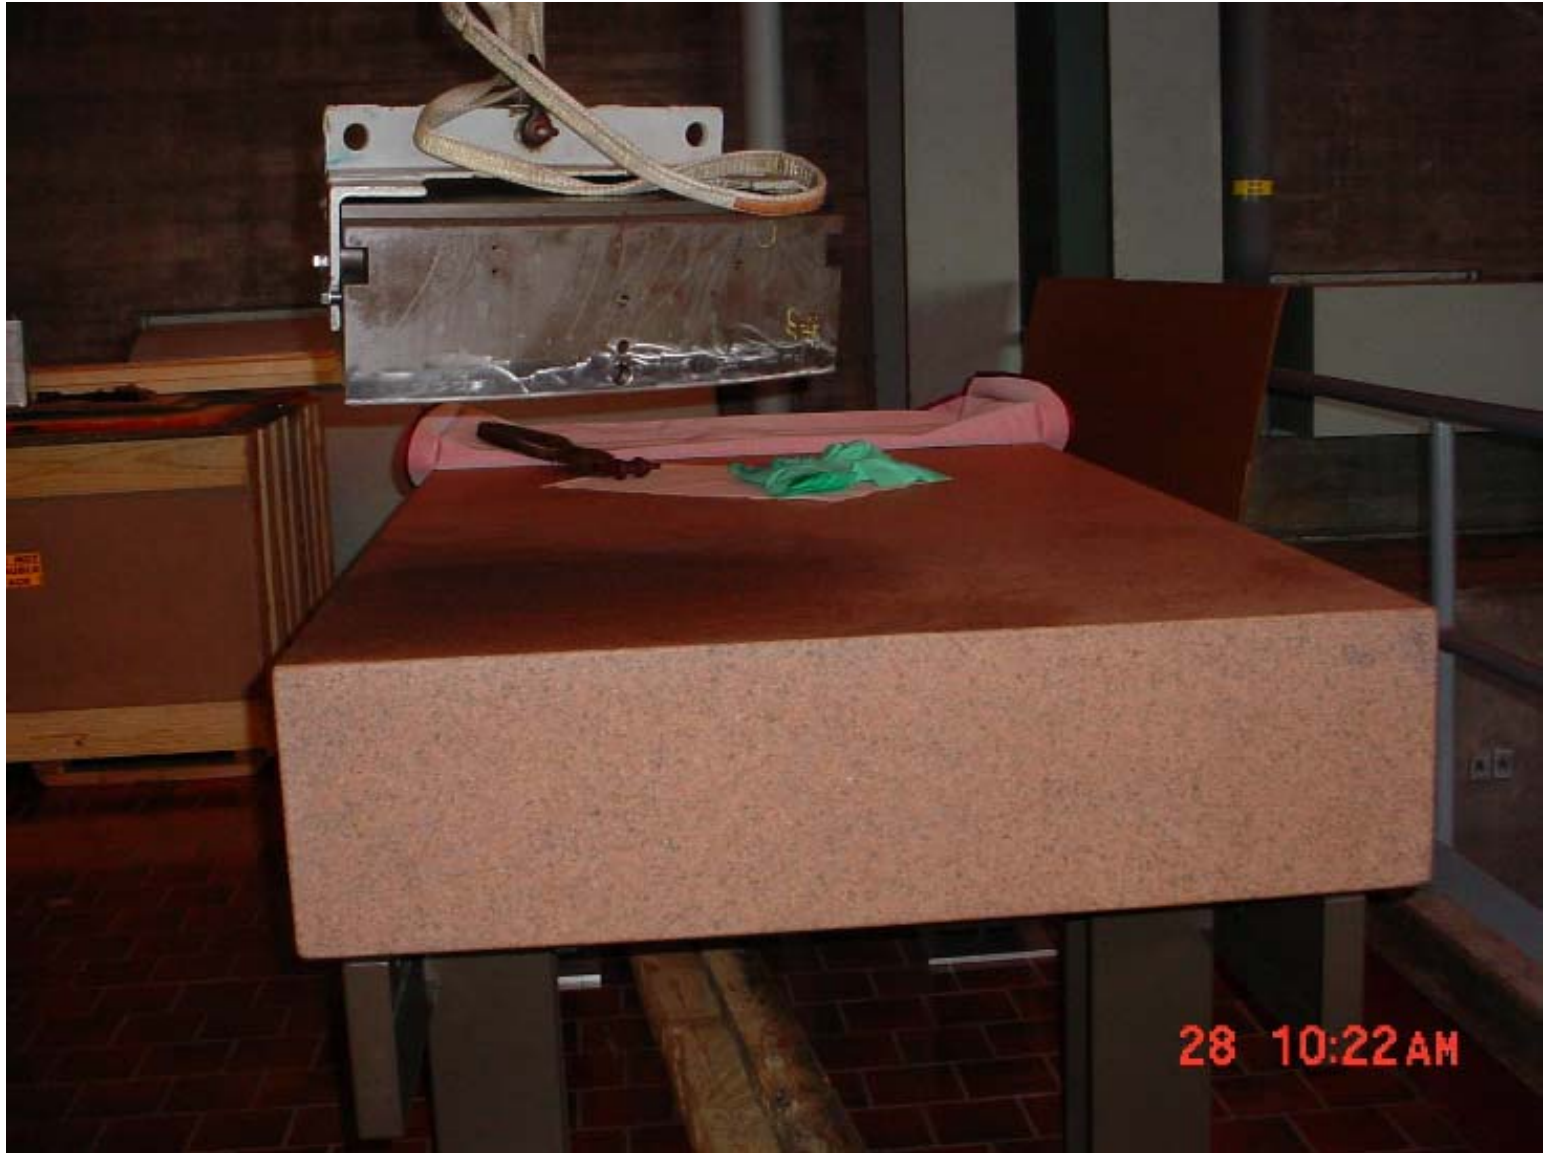
Picture 2 (Granite Surface):

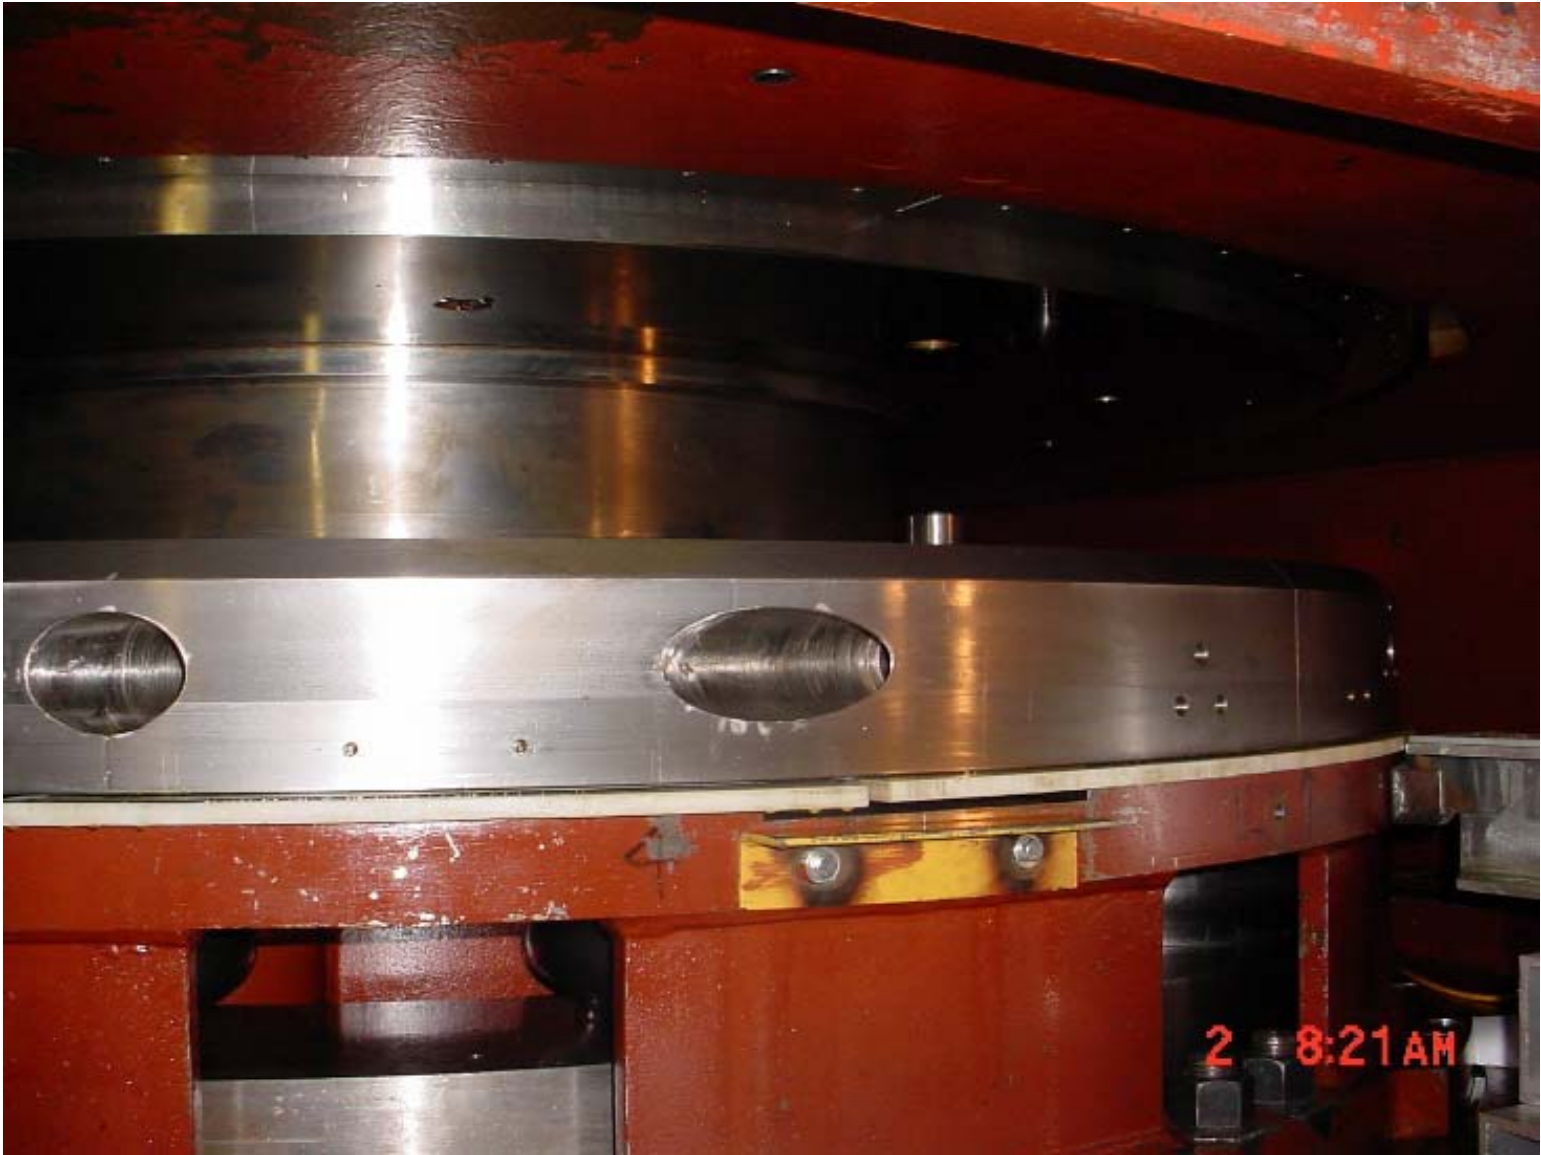
Picture 3 (Removal of the Thrust Runner):

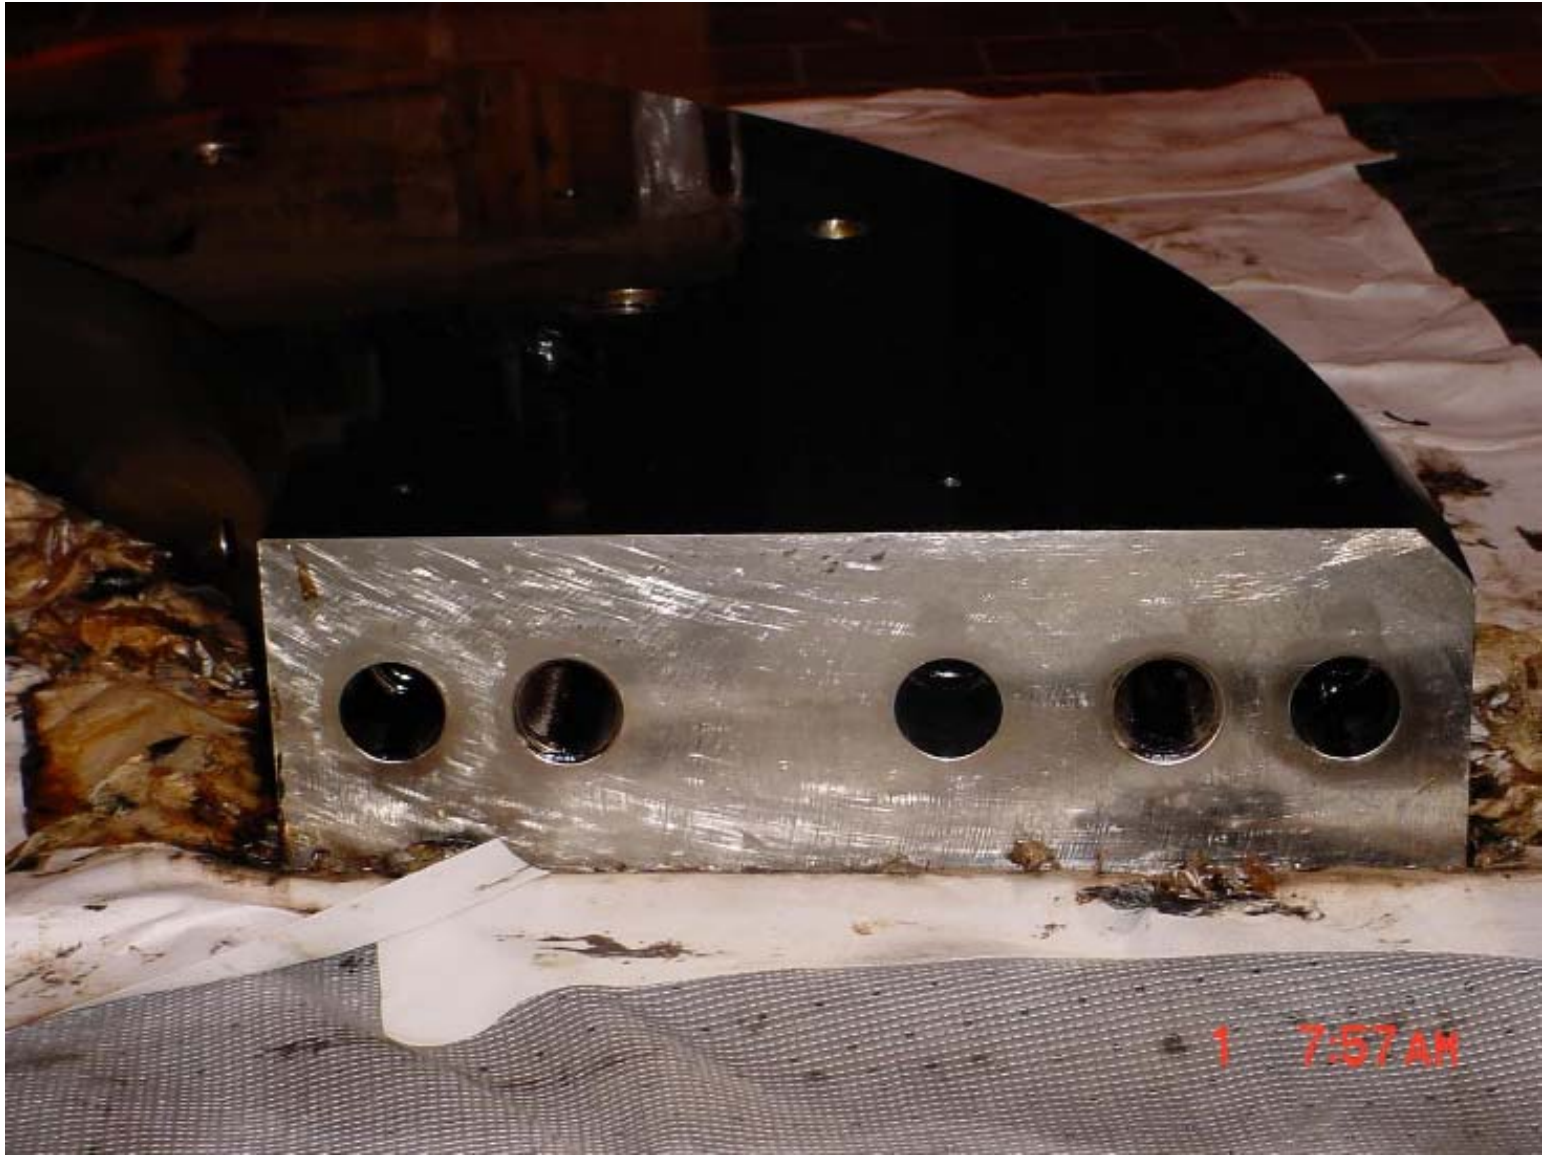
Picture 4 (End View of New Thrust Runner):

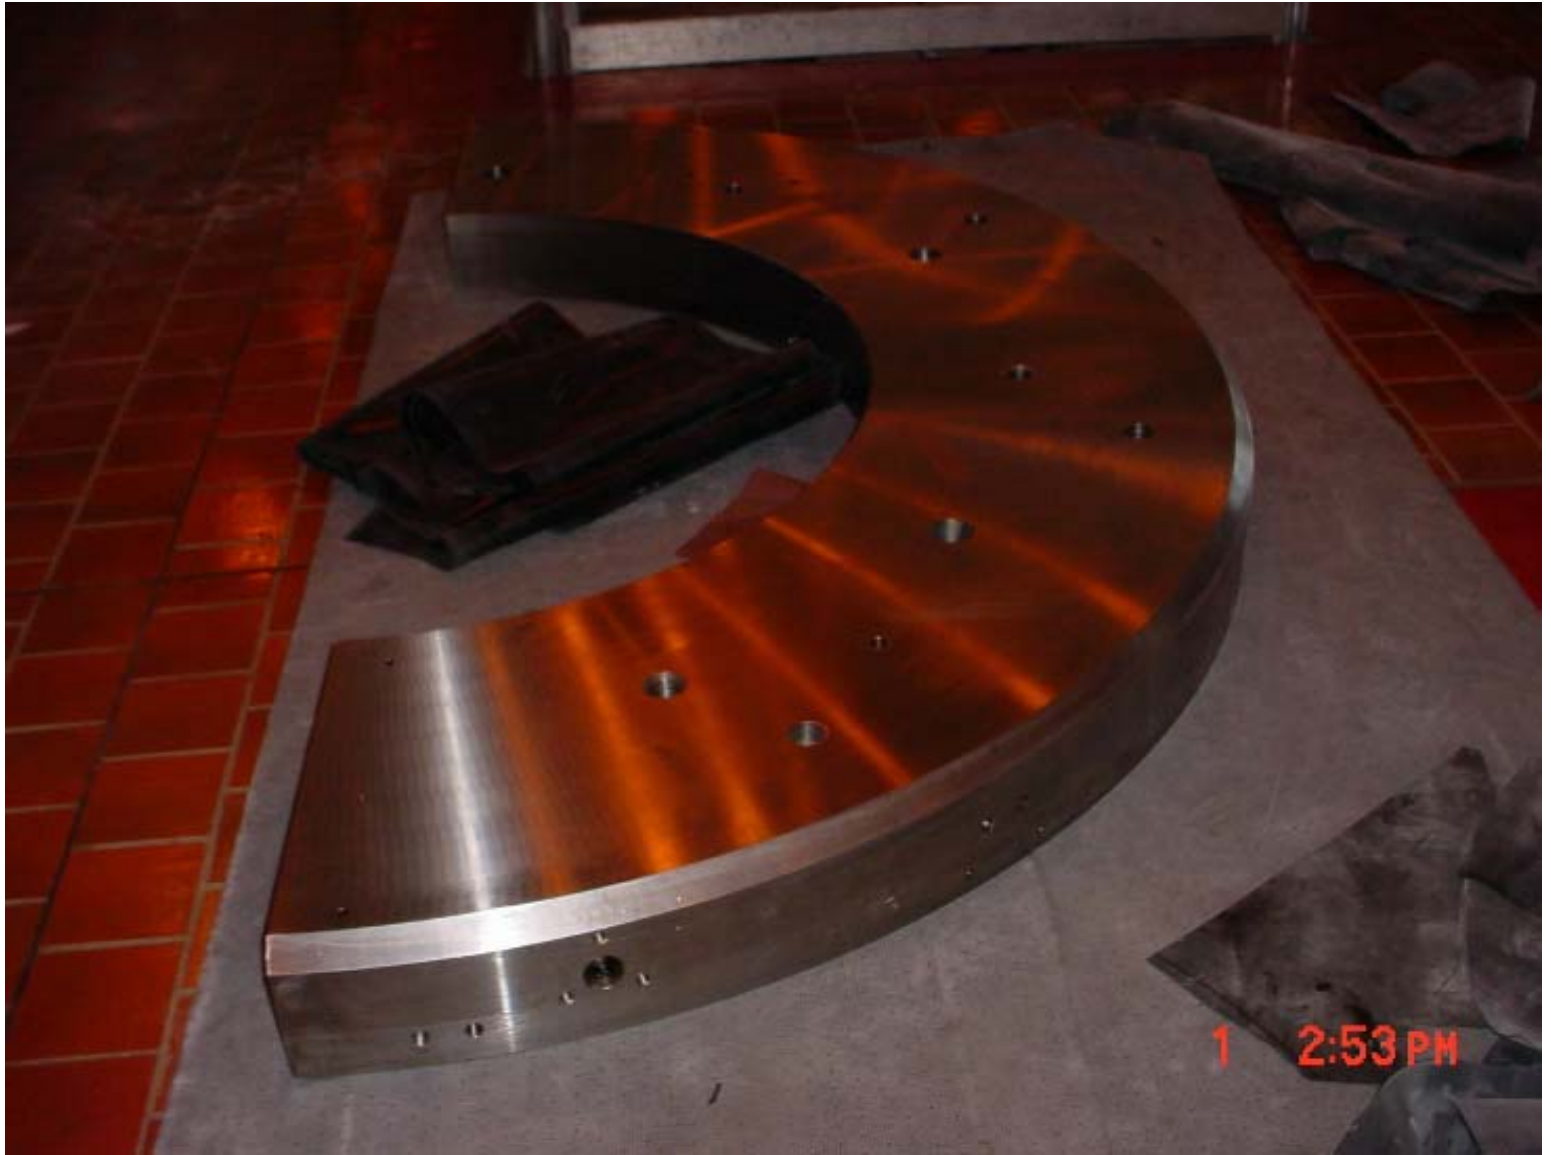
Picture 5 (Shaft Side of New Thrust Runner):

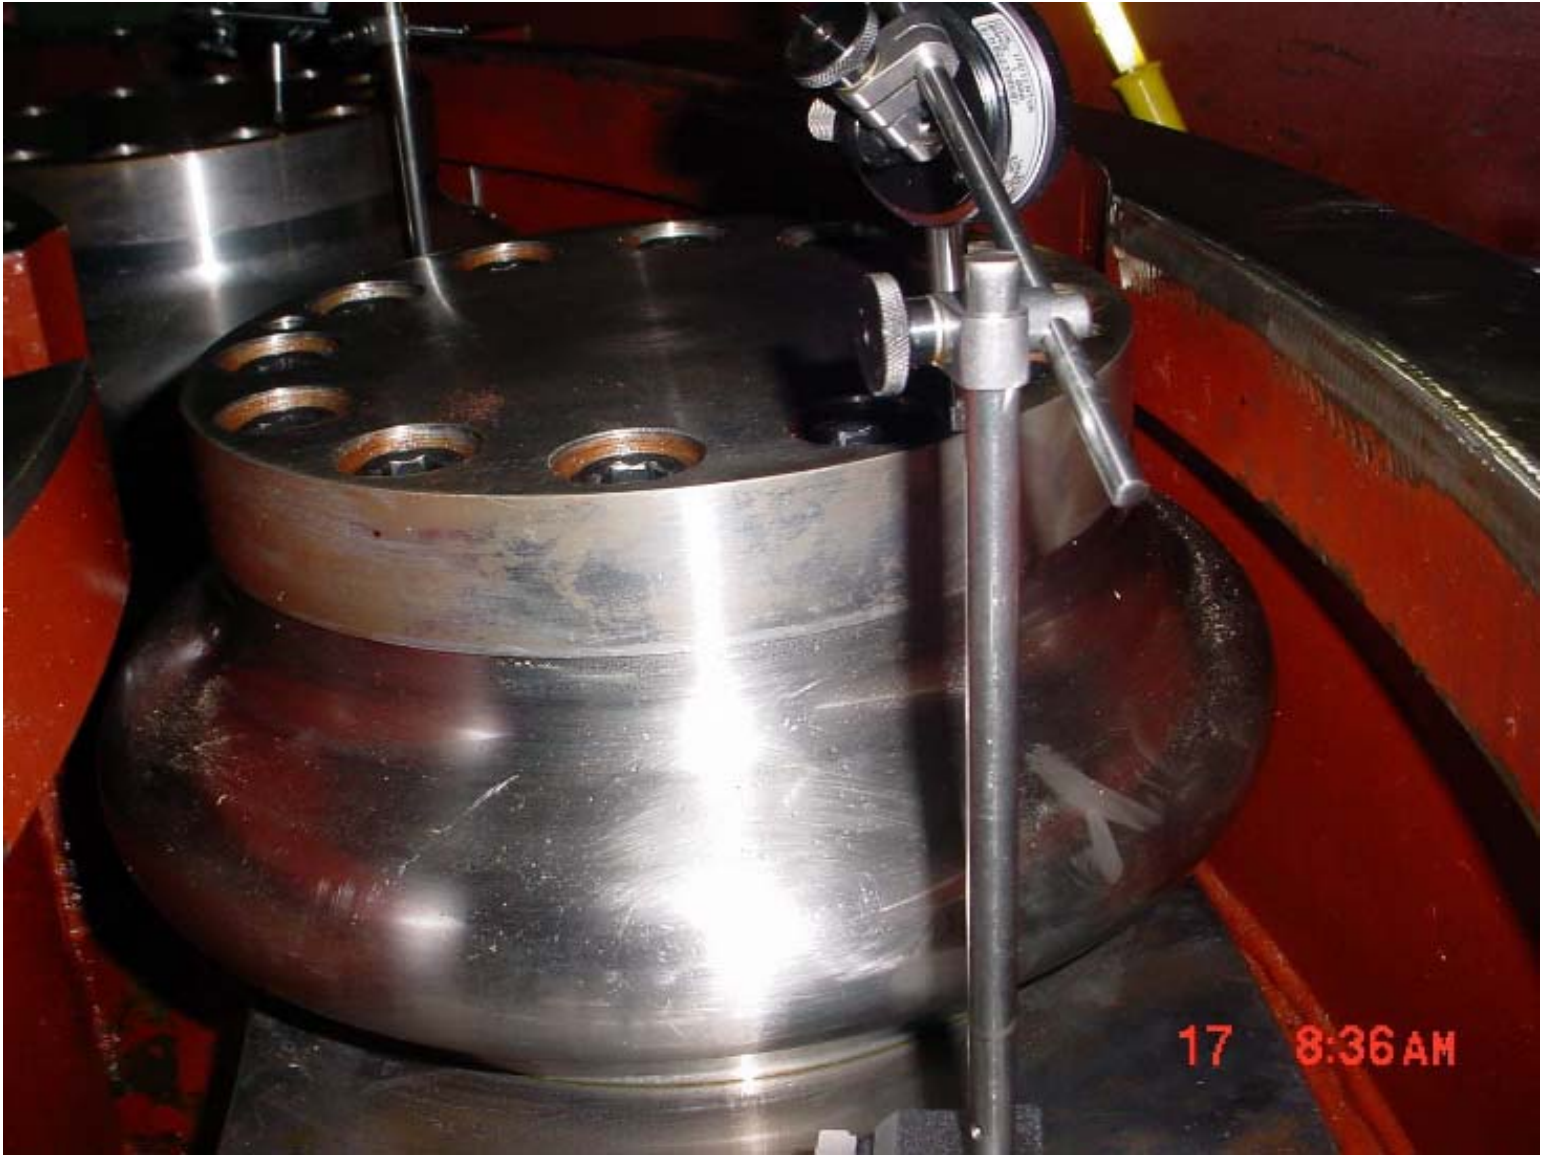
Picture 6 (Mushroom Check Close-up):

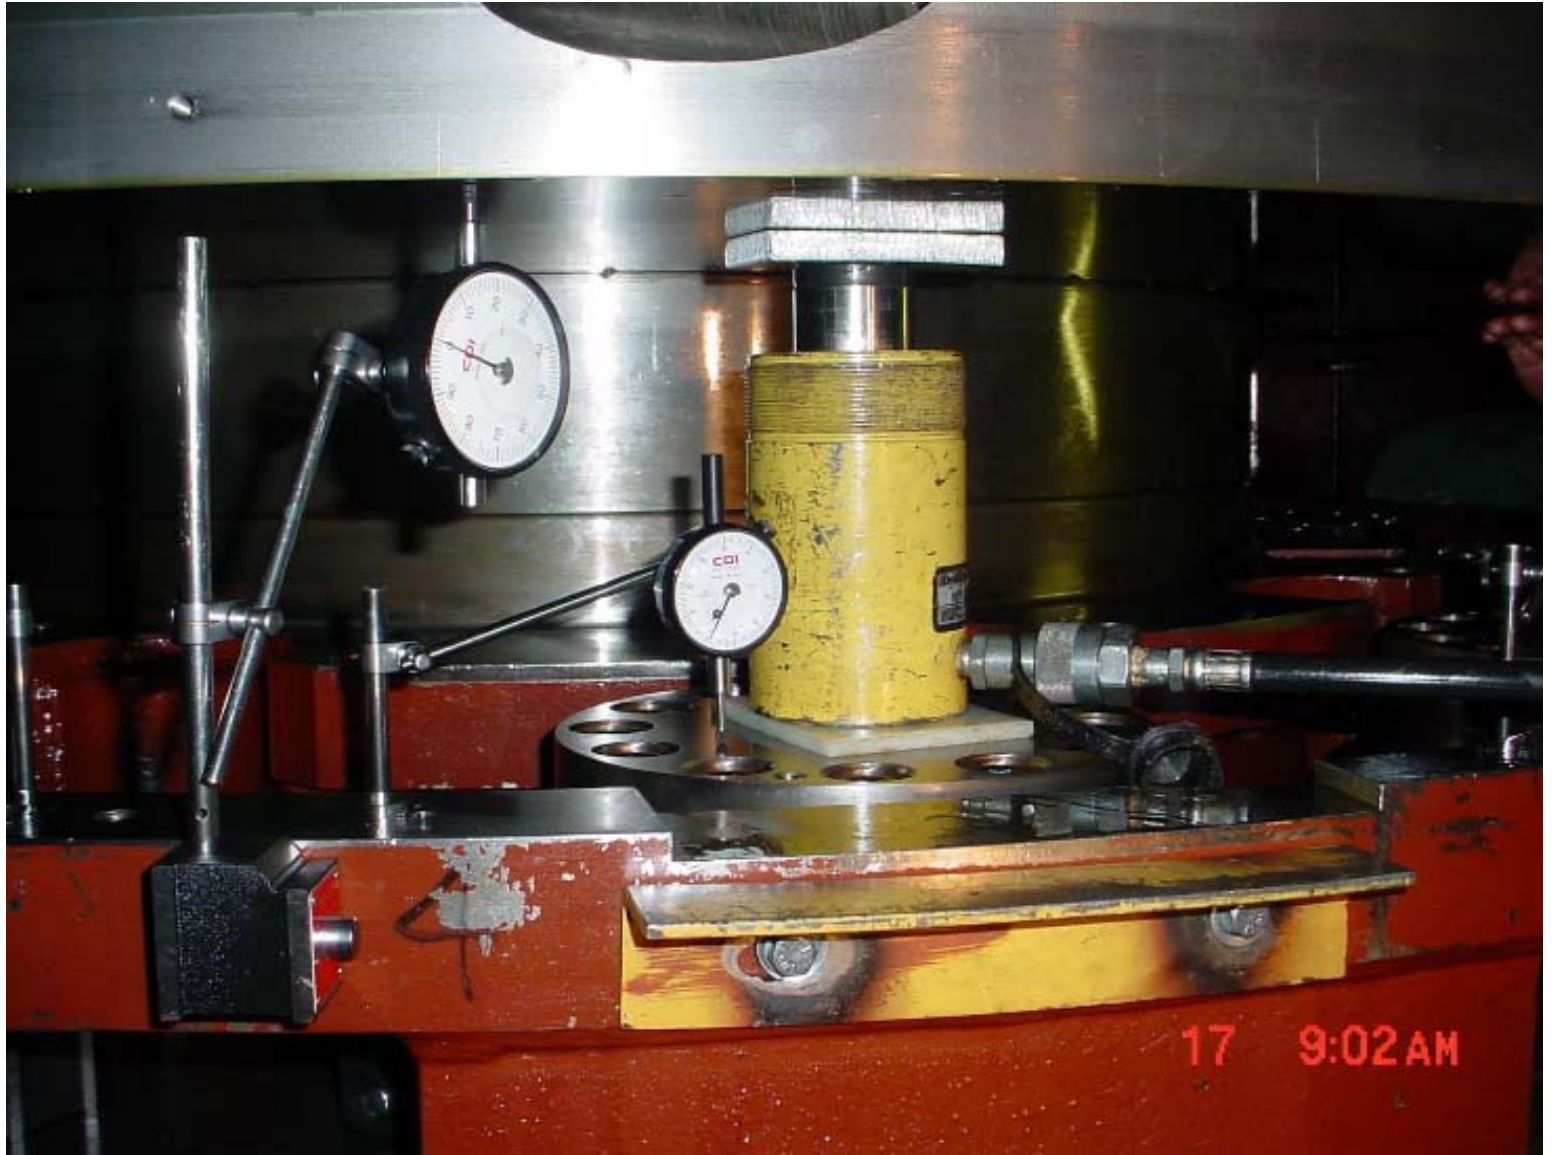
Picture 7 (Mushroom Check with Hydraulic Ram):

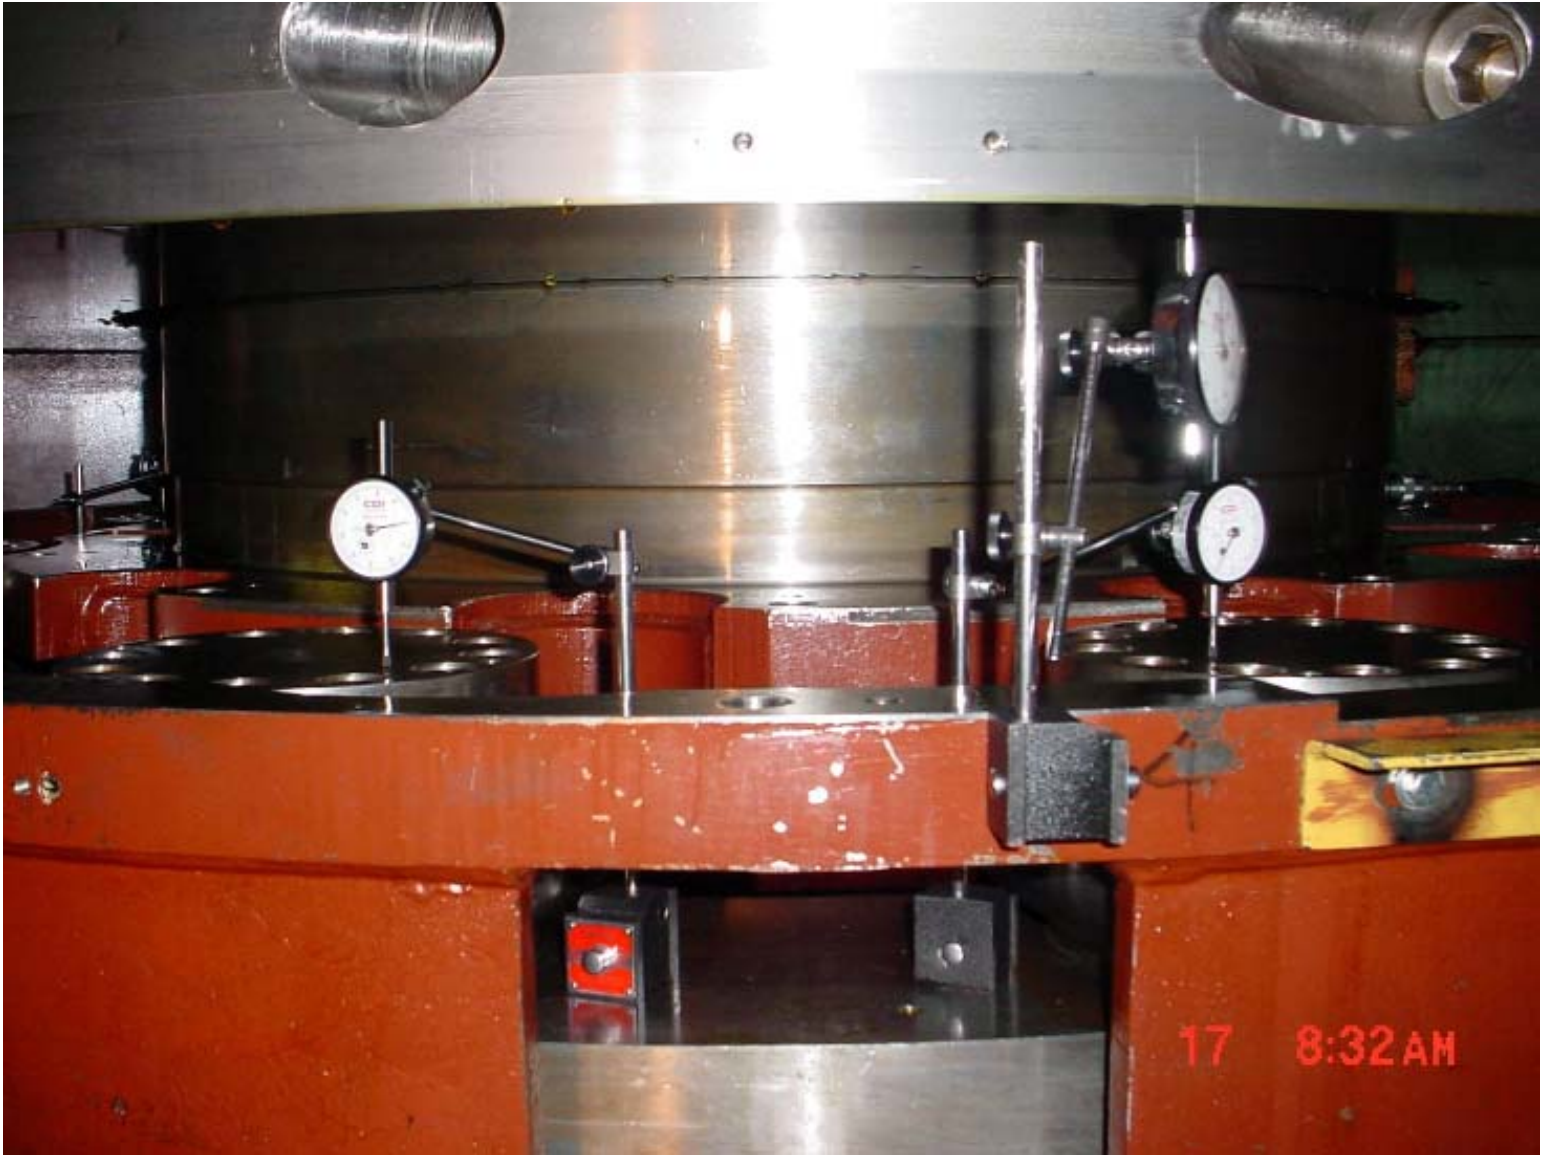
Picture 8 (Mushroom Check):
